FRACTURED PAINT BOX ~ TP 364 Correction on Unit FPB Accent TLS1, TLS2, and TLS3.

Applies to all Patterns with a Print Date from 5/15/17 to 11/3/17.

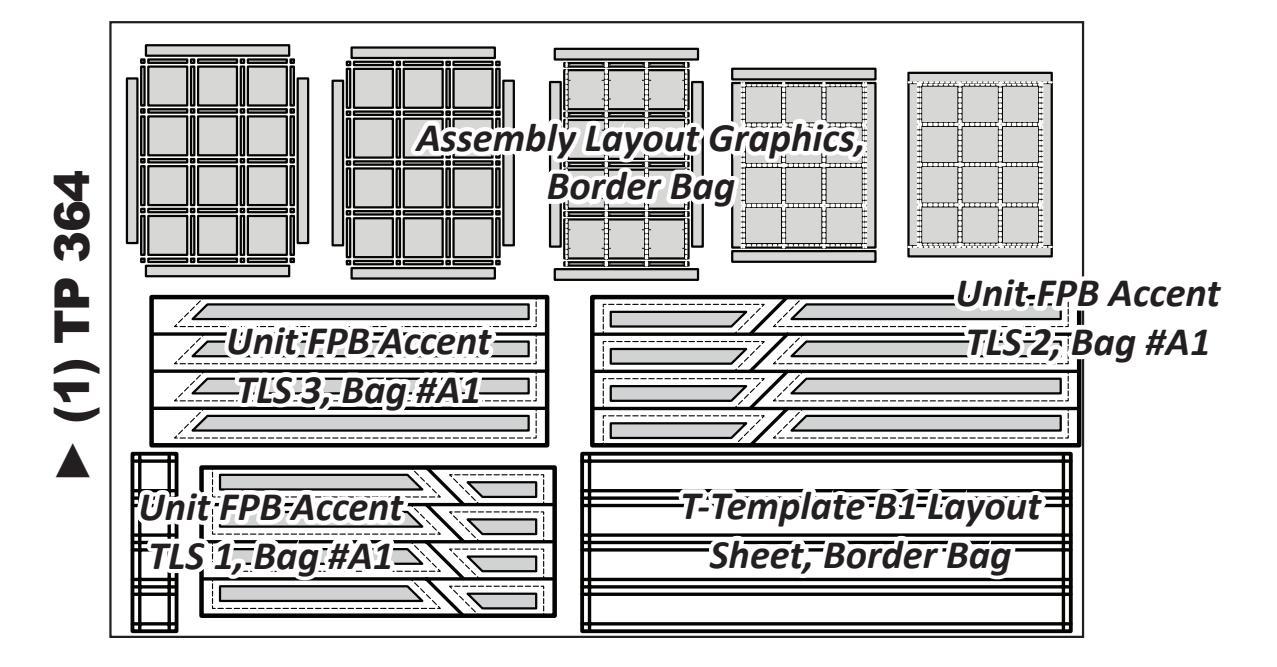
CORRECTION: The angles on TLS1 and TLS2 are backwards. TLS3 cuts into a rectangle, so although the angle is not shown correctly on the TLS, it will not impact your cut. Section 10 will be just fine! The TP 364 Graphic below shows the angles you SHOULD have.

The correction for the other sections is SIMPLE if you have not cut your fabrics.

Please cut your fabrics WRONG-SIDE-UP. Then, flip them over, RIGHT-SIDE-UP before you piece.

If you have already cut these pieces and cannot get them to fit, do the following:

If you purchased a kit using the Tonga Batik Espresso, just flip the pieces over and move on. It's the same front and back!

If you are using something else, you can do the following: Section 10 is Correct, so this piece can be used. The others technically fit, but are right up to your seam allowance so if use them, you may be short. Try it, and if you can't make it work on one block, then we recommend using the Sec. 4 piece for Section 2, the Section 6 piece for Section 4, and the Section 8 piece for Section 6. Ignore the angles. You will still be missing the Section 8 piece. **You will need an extra 1/2 Yard of Fabric.** You can then cut (**12**) 1-1/4° x 42° strips. Stack these and subcut them into (**4**) 1-1/4° x 10-1/2° rectangles.
